# SLATE ROOFS

## WHY LEARN THE HARD WAY?

By Joseph C. Jenkins

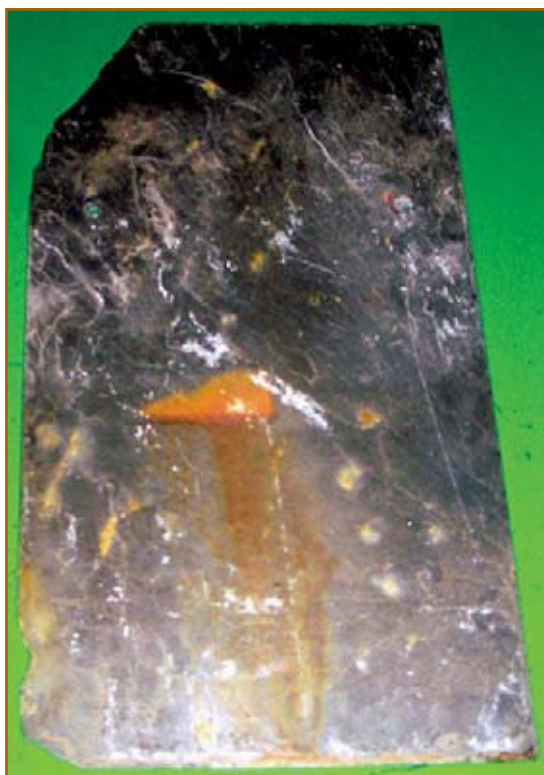
***Figure 2 – This Spanish black slate leached rust stains down the new slate roof. This photo shows the slate after only one year on the roof.***

Some Spanish black slates are known for their pyrite content, which will bleed red rust stains down the roof. *Figure 2* shows such a slate, taken from a residence in

Florida after only one year on the roof. This large residential roof had to be completely reslated at great expense. The owner of the residence selected this slate because he liked the shade of black on a new sample piece and did not understand that some slates will change in appearance with exposure to weather. When selecting Spanish slates, it is important to know whether those being considered are pyrite-bearing, a condition that may or may not be obvious by visual inspection. In a recent case on the east coast, an entire church roof had to be reslated because the new, Spanish black slates were bleeding rust down the roof, and the church people did not like the way it looked. Again, this is not to be construed as a condemnation of all Spanish black slates, as some are quite good.

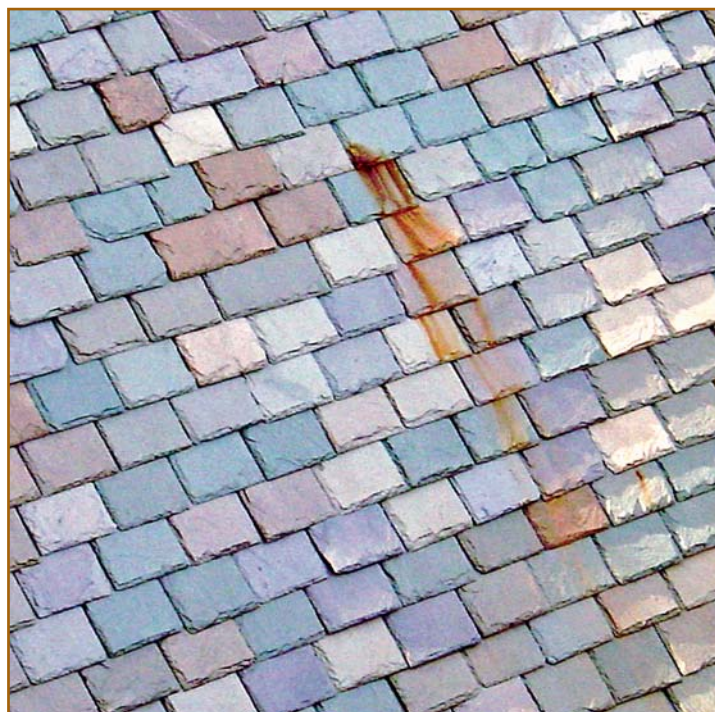
***Figure 3 – Even domestic slates can rust. These Vermont slates on a high-rise apartment were poor in quality and should have been screened for pyrite inclusions.***

Poor-quality slates occasionally originate from the United States. This may be due to the manufacturer's not culling out rejects, for example. Shoddy quality control can lead to rusting pyrites on even the best American slates. *Figure 3* shows Vermont slates badly rusting down an apartment building roof. This is very unusual and indicates a commercial source of roofing slate that should have been avoided or a bargain slate that wasn't worth the money combined with a contractor who should have culled the defective slates out but didn't know what a bad slate looked like.

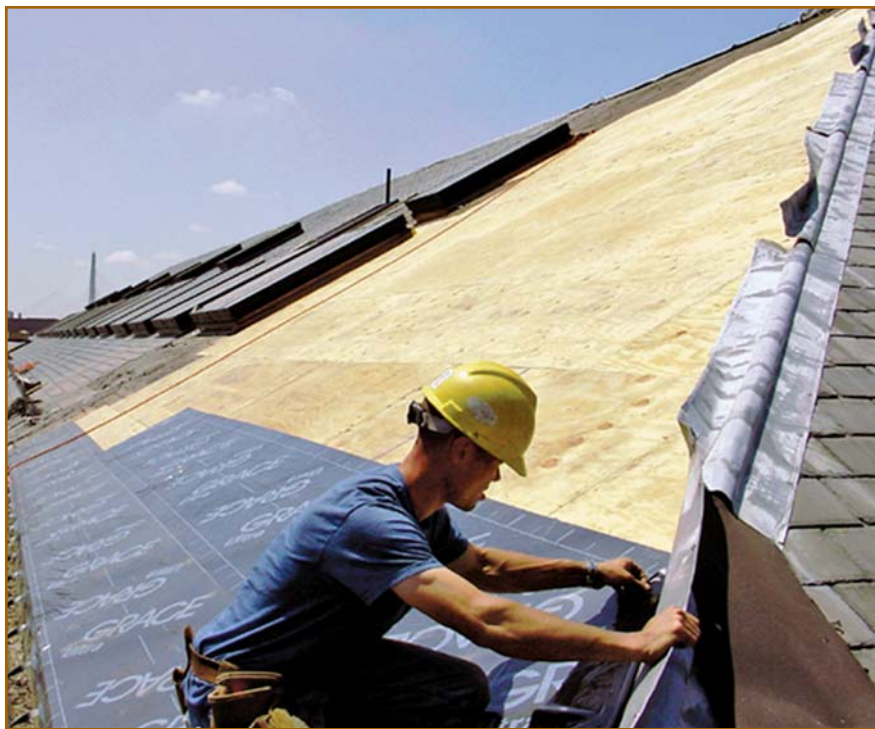
**Figure 4 – Traditional slate roofing systems, despite their incredibly successful performance, are being largely abandoned in favor of plywood roofs with peel-and-stick underlayments.**

Figure 4 shows a 150-year-old slate roof being replaced in Boston. Although the roof was still functioning at the time of replacement and the existing roof system – made of slate, 1-in boards, 30-lb felt, and nails – had demonstrated a 150-year performance, the contractors who replaced the roof completely abandoned the existing system and replaced it with one that had no proven longevity, emphasizing underlayment and completely eliminating any chance of air transpiration. The original 1-in roof board deck, still sound, was covered with ½-in plywood, then self-adhered modified bitumen, then 30-lb felt, and then slate. Will this new roof system last 150 years? Time will tell, but why reinvent the wheel? A chain is only as strong as its weakest link. Traditional, 3-link slate roofing systems have already proven themselves, are less expensive, are more environmentally friendly, and take less time to install. If one wants to guarantee that a slate roof will last a century or two, traditional methodologies should be followed.

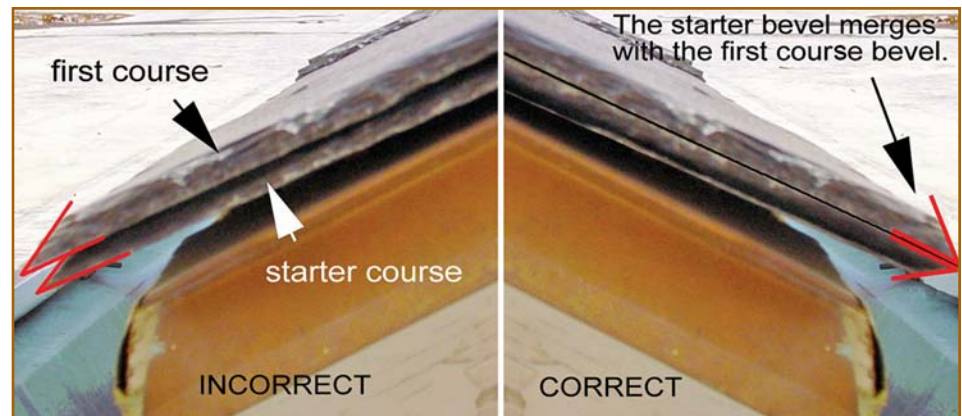
**Figure 5 – The starter course should be flipped over and laid upside down as shown on the right in this illustration. This creates a clean drip edge and allows for correct nail countersinking.**

quarry with the intention that the slates are to be installed face down. This allows for a clean edge where the starter slate meets the first course (Figure 5). The reason it's important to know this information is because the orientation of the starter course is an indi-

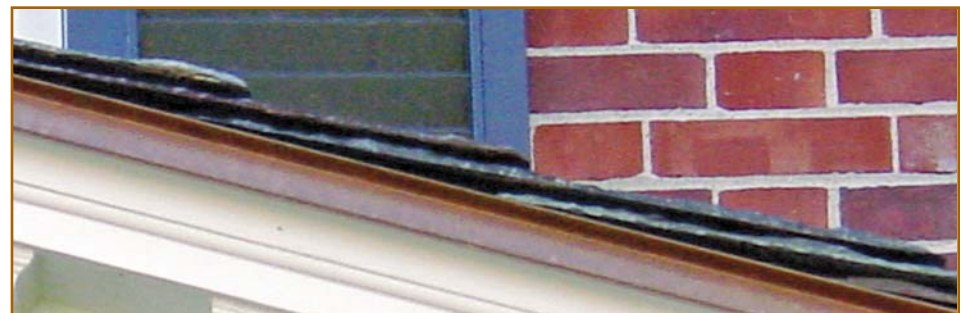
**Figure 6 – No slate lies flat on a slate roof. Every slate is angled, which is why it should not be walked upon and why the starter course requires a cant.**

match the angle of all the other slates in the field of the roof. No slate lies flat on the roof because every slate is overlapping other slates, as shown in Figure 6. Since the starter course does not have a course of slate underneath it, something else must be

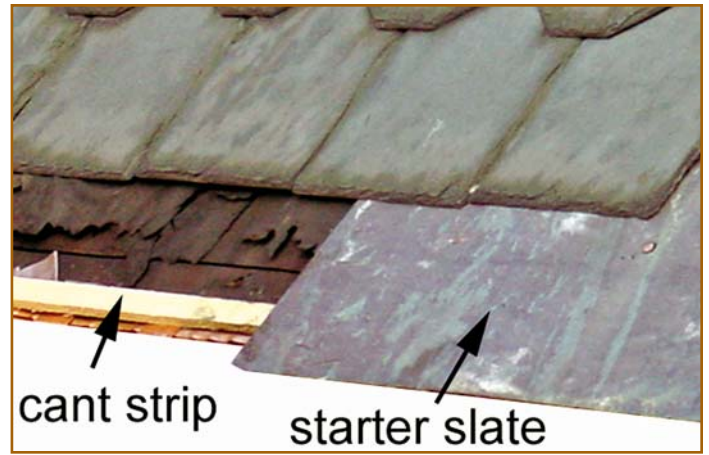
**Figure 7 – Note that the starter slate is laid backside up and is propped up by a cant strip.**

installed under it to create the proper angle. Typically, this is done by installing a wood strip (*Figure 7*), but it can also be achieved by using a metal drip edge with a cant formed into the metal, or even by raising the fascia.

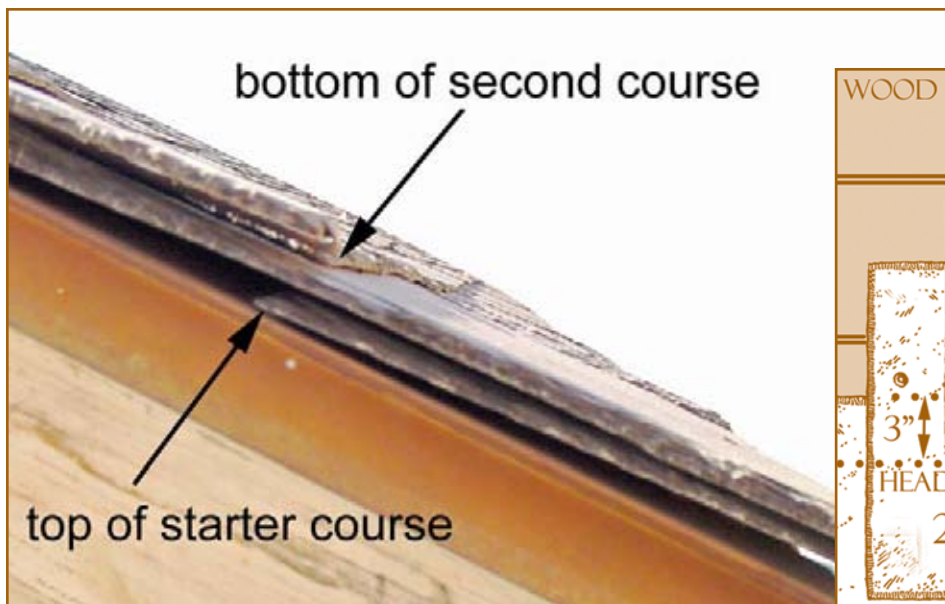
**Figure 8** – The starter course should be overlapped by the second course by at least three inches. In this case, it is not overlapped at all. This is a serious but common mistake. Note also that the starter slate is incorrectly laid backside down. This is an indication that the installer was inexperienced in laying slate.

Another very common mistake on starter courses is a lack of headlap, especially when the field slates are turned sideways and used for starter slates. The second slate course must overlap the starter course by a minimum of 3 in. Inexperienced slaters often overlook this important detail. Since the bottom of the roof has more water running over it than virtually any other part of the roof, it is imperative that the headlap on the bottom courses of slate be correct. An example of a starter course lacking headlap is shown in *Figure 8*.

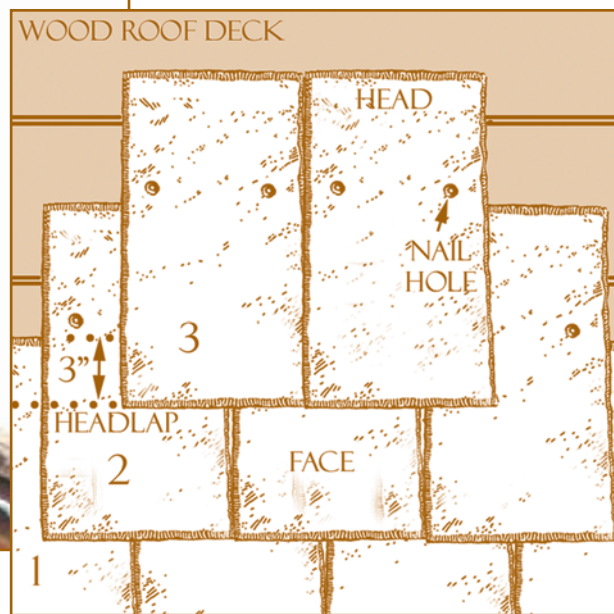
**Figure 9** – Headlap is a critical detail on a slate roof. Lack of headlap will cause an entire roof to be condemned.

Speaking of headlap, this is one of the first details that a roof consultant should look for on a new slate roof installation. If the headlap is missing or inadequate, the roof is probably going to be condemned. Headlap is the overlap on each course of slate by the second course above it (*Figure 9*). This overlap is what prevents the roof from leaking. Three inches is standard, but headlap can vary according to the slope of the roof. *Figure 10* shows a newly installed shopping center roof in Louisiana with about an inch of headlap on the field slates. The overlap should be 3 in. There is no fix for this inadequacy other than to rip off the entire roof and start over. *Figure 11* shows a university building roof in Pennsylvania with a new slate roof – and, incredibly, negative headlap. This is the same as having holes all through the roof. It's hard to believe that roofing contractors can make

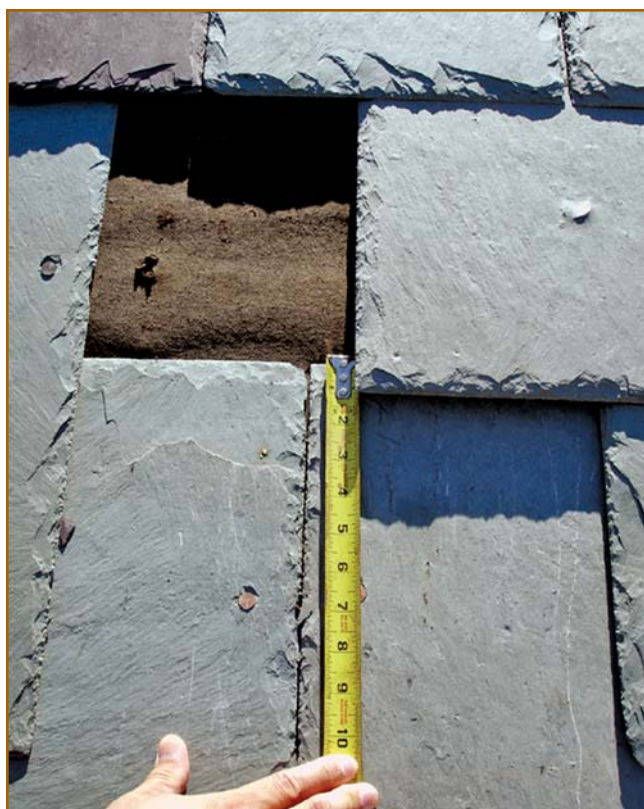
**Figure 10** – This is an example of inadequate headlap on a shopping center roof in Louisiana.

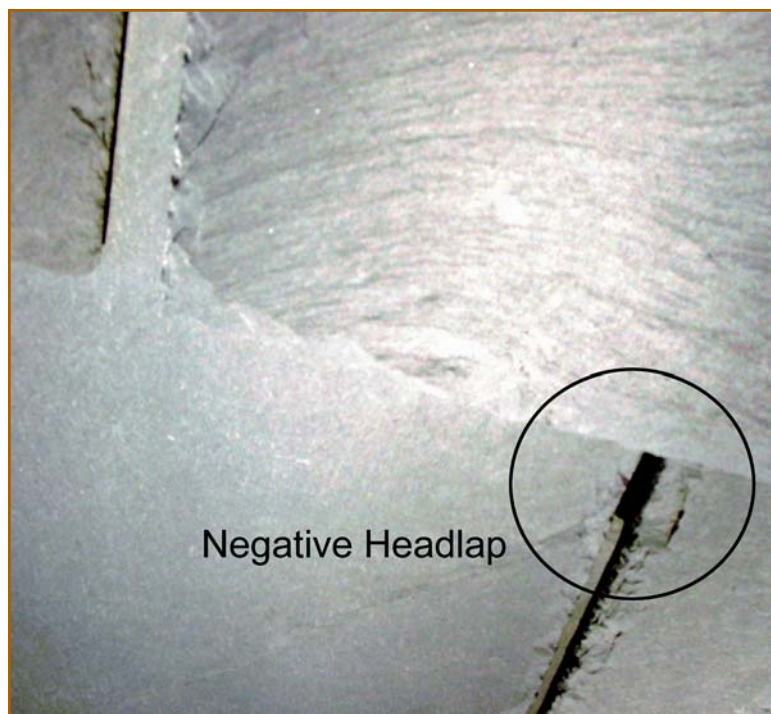
**Figure 11** – When the slate courses are spread too far apart vertically, negative headlap can result. Although this requires fewer slates to cover the roof, it also creates holes all through the roof. There is no remedy for an egregious error such as this other than to remove the entire roof and start over.

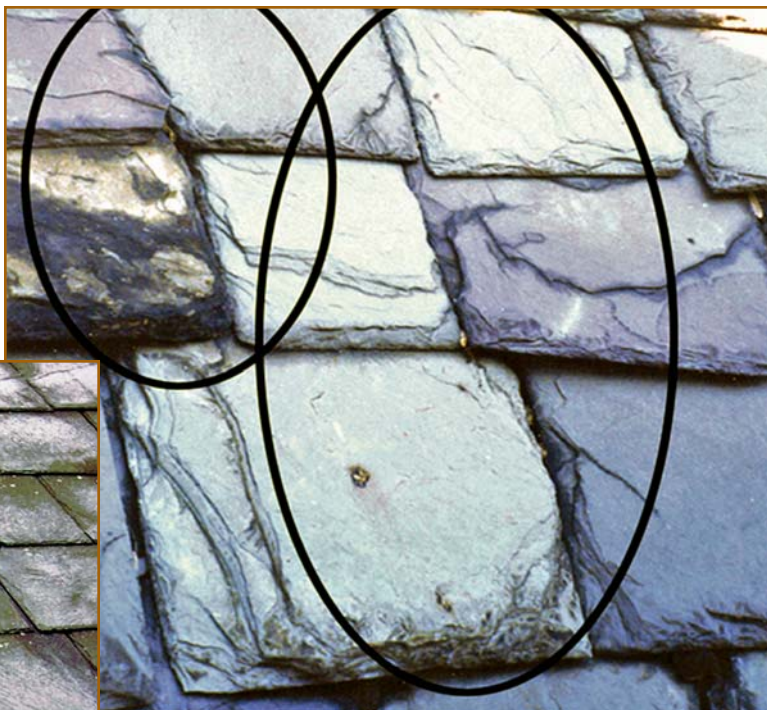
*Figure 12 – “Sidelap,” or lateral overlap, should be a minimum of 3 in. Here we see no lateral overlap at all. This entire roof had to be removed and reslated, as it also had no headlap.*

Lateral overlaps or sidelaps should also be 3 inches minimum. However, don't be surprised to see slates with no lateral overlap at all, as shown on an historic building in Georgia (*Figure 12*). Incorrectly placed sidelaps can leave the butt joint directly over the slating nails, as shown on an historic Pennsylvania State Park building in *Figure 13*. This will allow direct water entry through the nail holes.

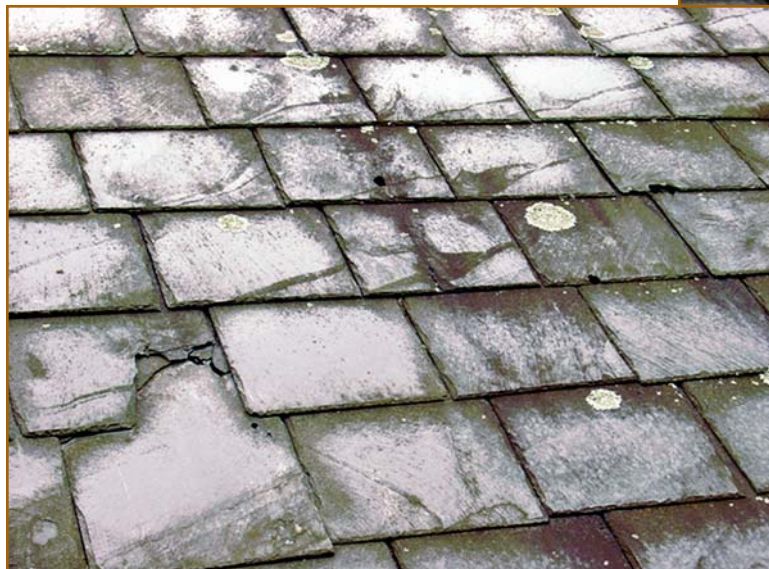
*Figure 13 – Each slate side-butt should be staggered so as to break the course below down the center. Instead, these slates were butted directly over the underlying slating nails, ensuring leakage.*

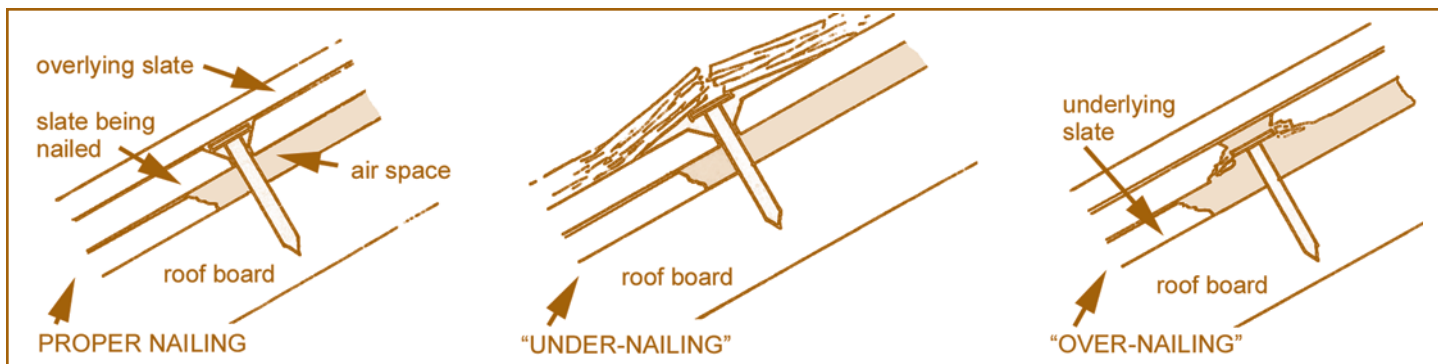
**Figure 14 – A good slater has no problem nailing slates correctly. When properly nailed, the nailhead just sits down inside the slate. When undernailed, the protruding nailhead, over time, can damage the overlying slate. When overnailed, the slate being nailed will crack, break, or cock awkwardly on the roof.**

Another common installation mistake is the overnailing and undernailing of the slates. Slate nail holes are meant to be crater shaped to allow the nail head to sit down inside the slate (*Figure 14*). Otherwise, the nail head will protrude and rub against the overlying shingle, eventually creating a hole (*Figure 15*). When the nail is not driven far enough, this is known as undernailing. Overnailing, on the other hand, is when the nail is driven too far and breaks through the slate. This leaves the slate hanging on one nail or sliding out altogether (*Figure 16*).

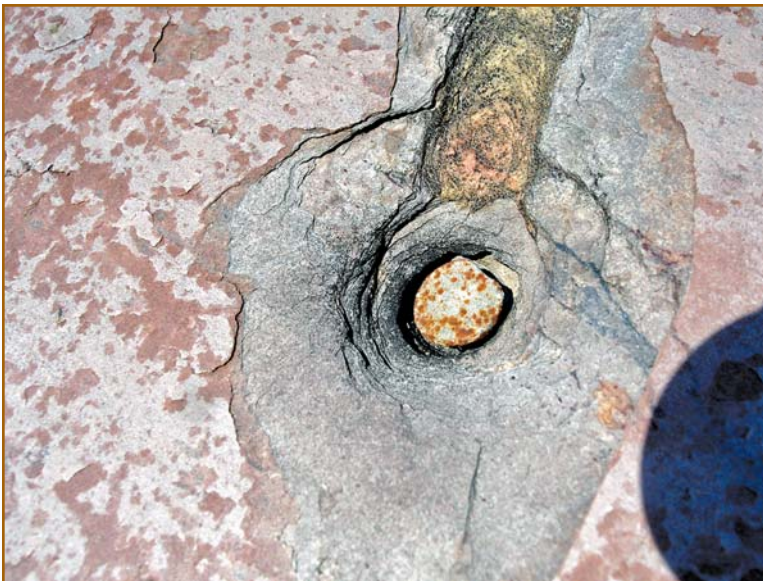
**Figure 15 – A protruding nailhead can eventually wear a hole in the overlying slate.**

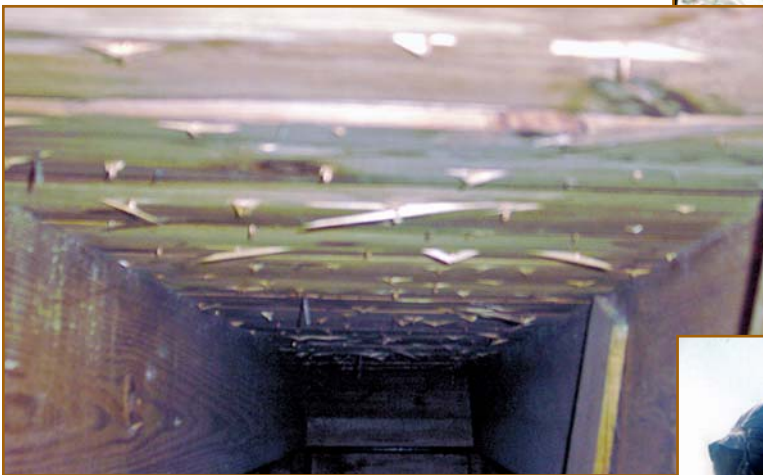
**Figure 17 – When the slating nails are too long, the back of the roof decking breaks out. This reduces the effective holding power of the nail. A longer nail, therefore, does not mean more holding power. The best nail length just barely penetrates the roof deck.**

Nail length is an issue that is commonly off the radar screen of the average roofing contractor. The slating nails should barely penetrate the roof deck boards. If the nails are too long, they break through the back of the boards and splinter out of the wood, reducing the board thickness where the nail is located and undermining the effective holding power of the nail (*Figure 17*).

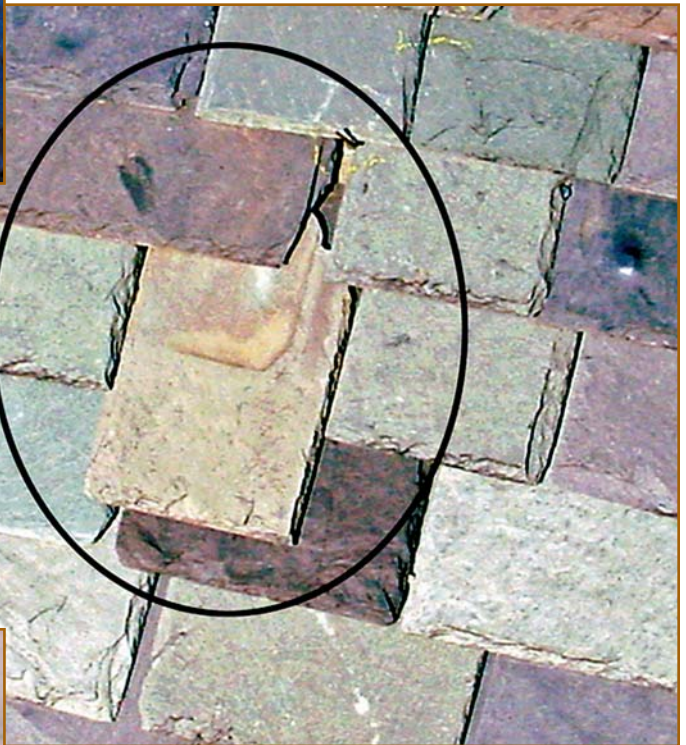
**Figure 16 – This slate was nailed so tightly that the nails broke through the slate and the slate is now sliding out of place.**

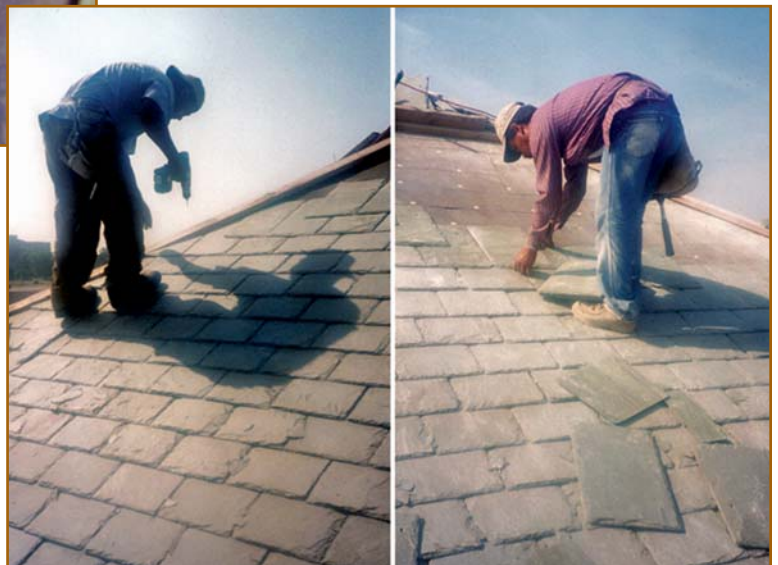
**Figure 18 – It is a mistake to walk on a slate roof during installation.**

A very common error with new slate roof installations is what I call the Bigfoot Syndrome – roofers walking on the slates during installation, as shown in *Figure 18* on a new bank building in Kansas. An experienced slating crew will make every effort to keep off the slates during installation by staging the roof correctly (*Figure 19*). When Bigfoot walks all over the slates, the shin-

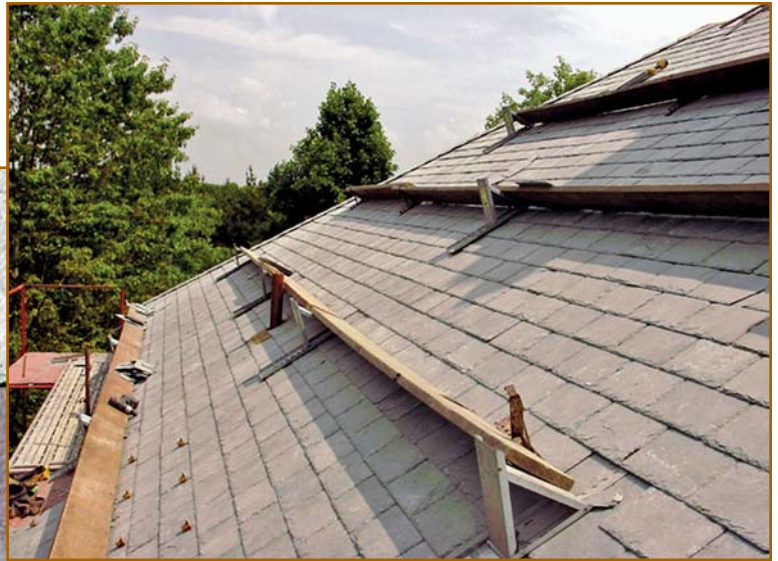
**Figure 20 (left) – Slate roofs that are walked on during installation will shed slates after the roof has been installed, perhaps for years.**

gles crack and break (Figure 20). They may not fall apart immediately, but I have seen a hundred slates fall off a new slate roof within five years of installation due to damage by foot traffic during installation.

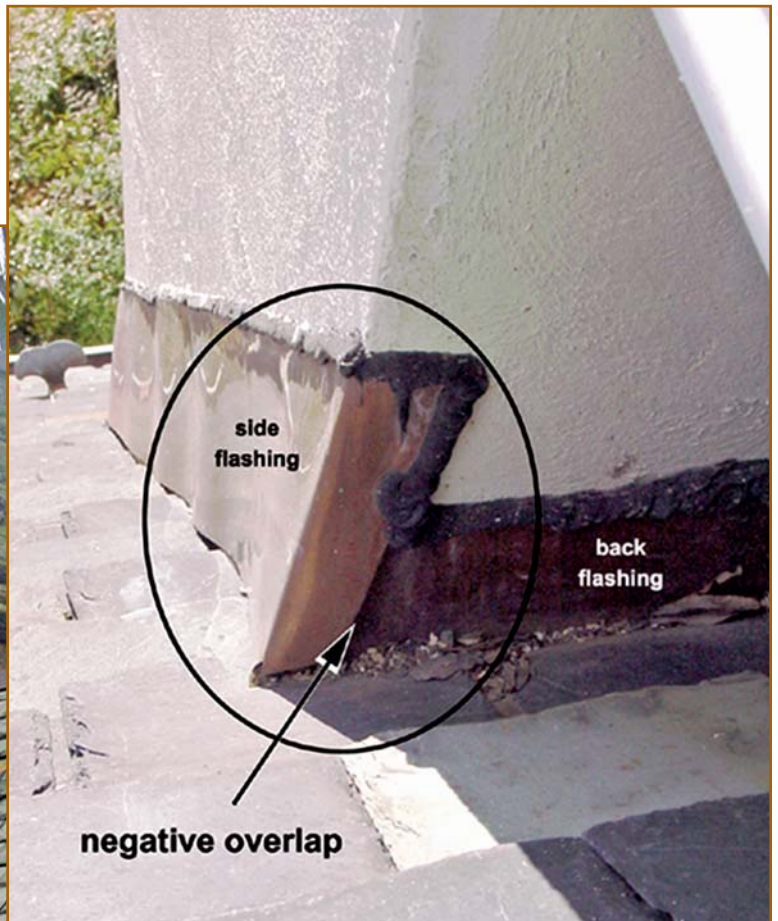
**Figure 21 – Uphill flashing should always lap on top of downhill flashing. Negative overlap, as shown, will leak.**

Flashings provide all sorts of opportunities for error. Negative overlap, for example, is sure to leak. Figure 21 provides an example of negative flashing overlap. Uphill flashing should always lap on top of downhill flashing. When lower flashings lap on top of higher flashings, water can enter the roof. Corner joints on roof penetrations are also commonly flashed incorrectly; chimneys provide a perfect example. The corner flashings must be either folded correctly or soldered in

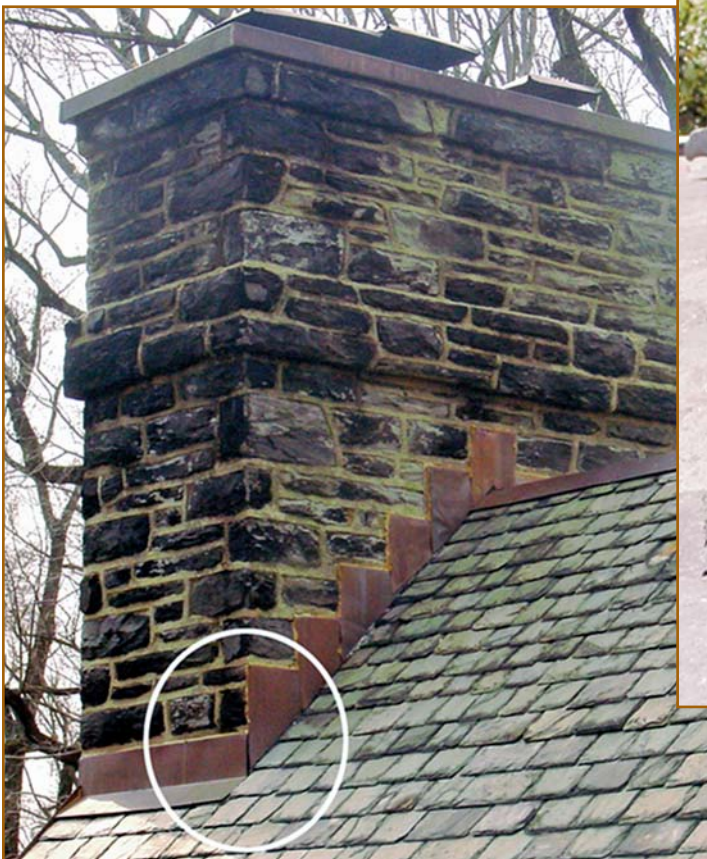
**Figure 22 (left) – Chimney corner flashings should be either folded or soldered. If neither is evident, then the corner is either sealed with sealant or not at all. In either case, this is a leak waiting to happen.**

order to prevent leakage through the corner. If a corner isn't folded or soldered, as shown in *Figure 22*, then the only thing keeping it from leaking is caulk or sealant, which do not have adequate longevity. An incorrectly folded chimney corner is illustrated in *Figure 23*. This is a leak waiting to happen. Dormers also often have corners that need to be flashed. Without folded or soldered corners, a dormer can be left wide open and waiting for the first good rainstorm (*Figure 24*).

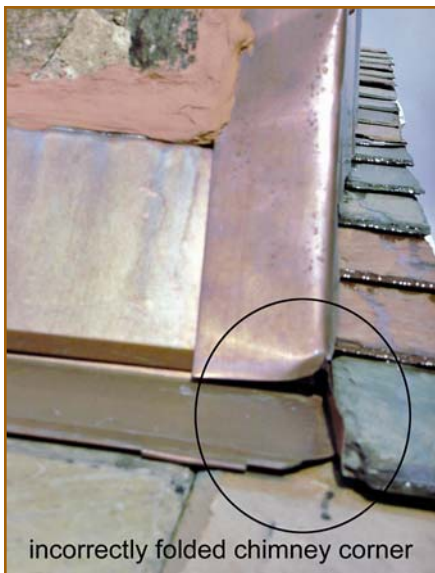
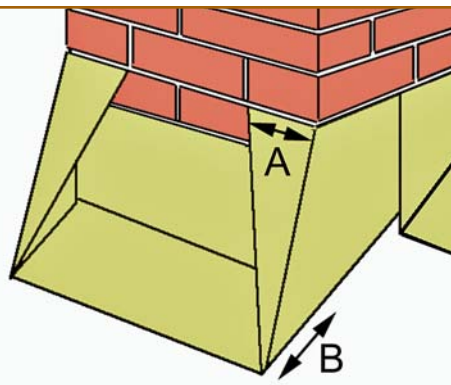
incorrectly folded chimney corner

A correctly folded chimney corner will ensure that A) water running down the chimney will not enter the corner, and B) water running down the roof will not enter the corner.

*Figure 23 – This chimney corner flashing (left), although folded, was installed incorrectly and will surely leak. A properly folded corner flashing must account for the water that runs down the chimney as well as the water that runs down the roof. In effect, the flashing should create a “miniroof” over each corner.*

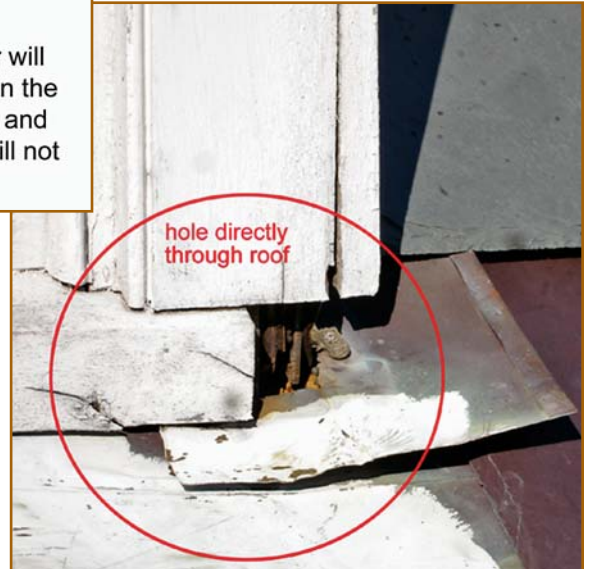
*Figure 24 – This is a case in which the corner flashing is neither folded nor soldered, leaving a large hole in the roof and clearly showing how corners need special attention in order to prevent leakage.*

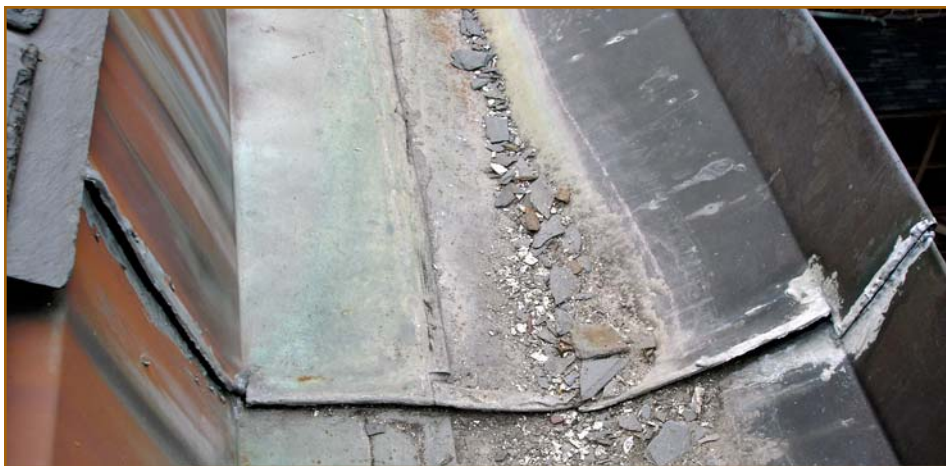
**Figure 25 – This is a perfect example of a new built-in gutter showing failed solder joints because not a single expansion joint was installed in the gutter system.**

Common on many slate roofs are built-in gutter systems. “Box gutters” require expansion joints, but they’re often installed without any allowance for expansion whatsoever. This becomes evident by the failure of the solder joints (Figure 25), which are then often roof-cemented after they start leaking in order

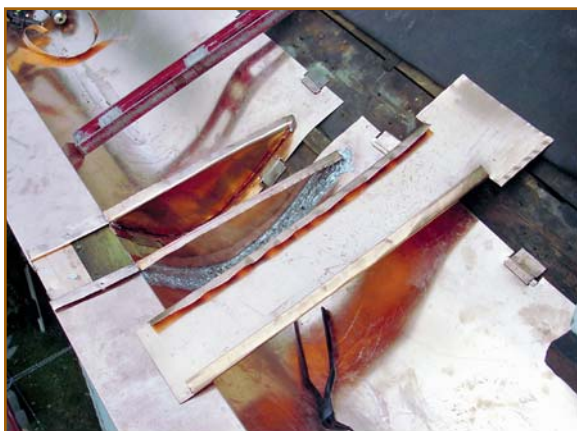
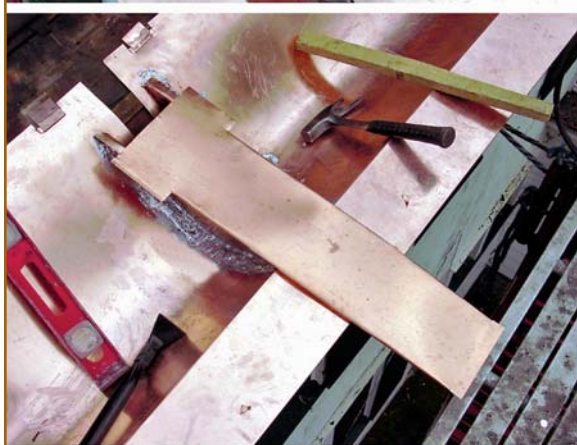
**Figure 26 (above) – Box gutters require expansion joints; otherwise, the solder joints will crack under pressure. This is evidenced by solder joints that have been covered by roof cement, a common sight on box gutters, both new and old.**

to alleviate the water penetration (Figure 26). Expansion joints (Figure 27) can be added after the gutters are installed, but it's a lot easier to install the gutters correctly in the first place.

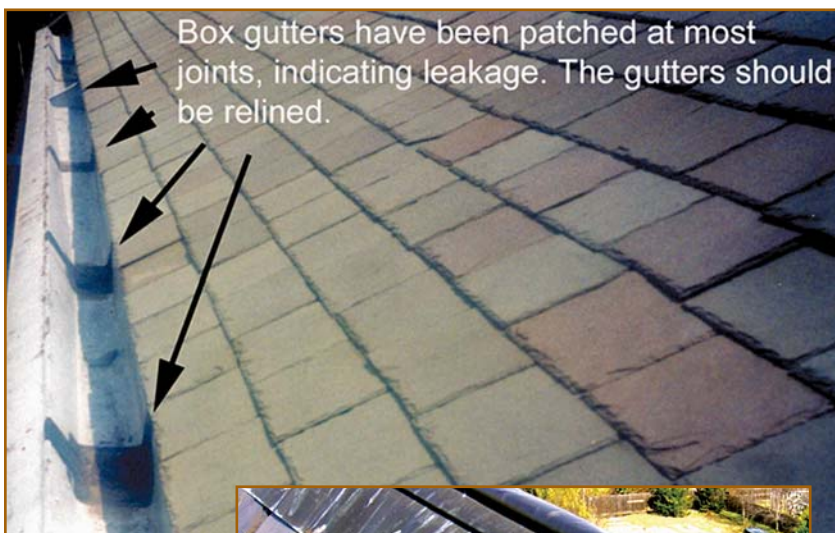
**Figure 27 – Expansion joints allow built-in gutters to move when expanding and contracting, thereby relieving the stress on the solder joints and prolonging the life of the gutter.**

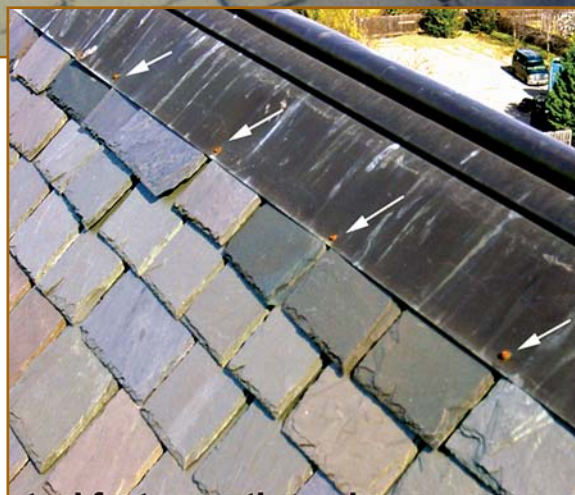
**Figure 28 – Metal fasteners should always be compatible with the metal they are fastening. Steel fasteners on copper, as shown, will deteriorate.**

A common sight on new slate roof installations is incompatible metals, often steel and copper used together (Figure 28). The copper will "eat" the steel, causing steel fasteners to degrade at an accelerated rate.

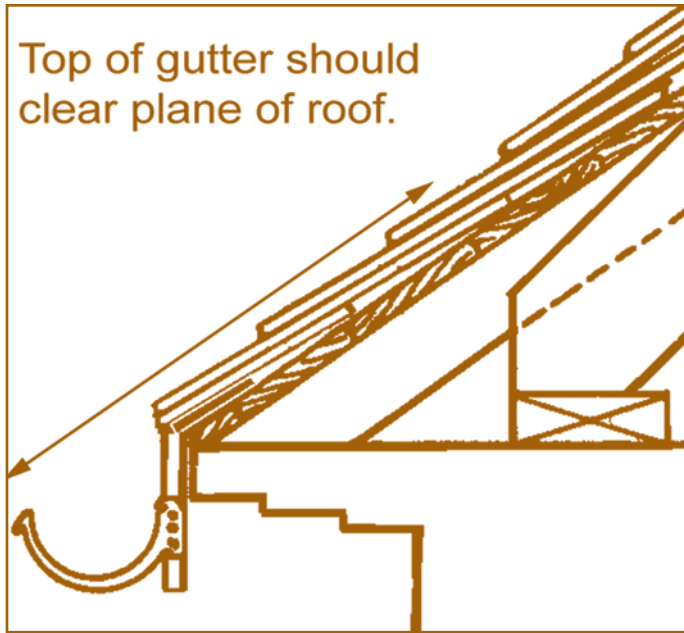
Top of gutter should  
clear plane of roof.

*Figure 29 – Ideally, the outer edge of external rain gutters should be hung below the plane of the roof to prevent damage to the gutters from sliding ice and snow.*

Speaking of gutters, they're often hung too high. The outer edge of external gutters should be below the plane of the roof (Figure 29) if the gutters are in locations where snow or ice could slide down the roof and knock them off. The gutter in Figure 30, for example, will not last long.

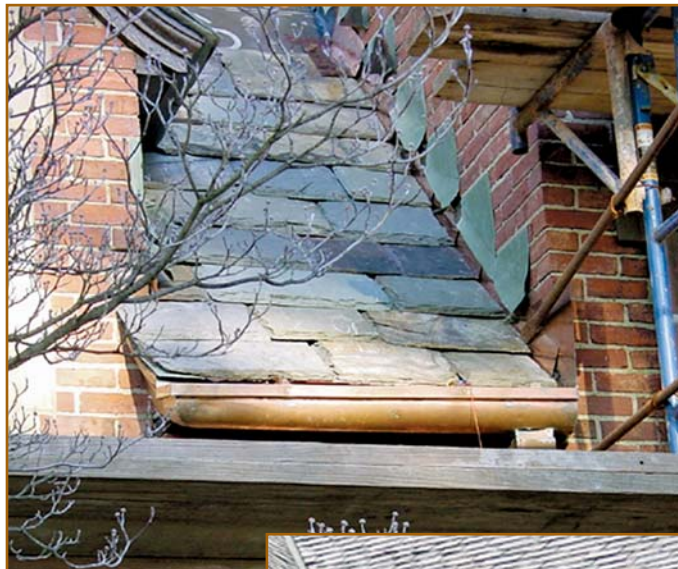
*Figure 30 – This gutter is just waiting for a snow avalanche to knock it off.*

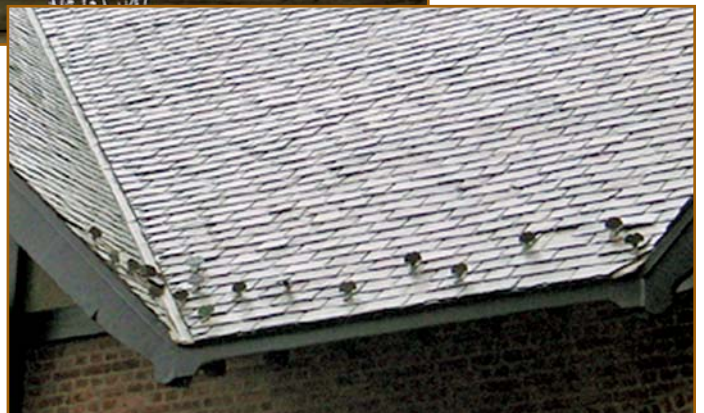
*Figure 31 – Snowguards must be installed in adequate quantities, or they will get knocked off in the first bad ice storm, damaging the roof in the process.*

Snow retention systems are another source of problems when they're installed incorrectly. One of the tricks for a proper snowguard installation is to use enough of them. Otherwise, they won't be able to hold the weight of the ice and snow and will rip out, taking slates with them. A poor snowguard installation is shown in Figure 31. Insufficient snowguards on this large roof

caused many of the devices to rip out during an icy winter. Follow the manufacturer's guidelines when installing these important slate roof elements.

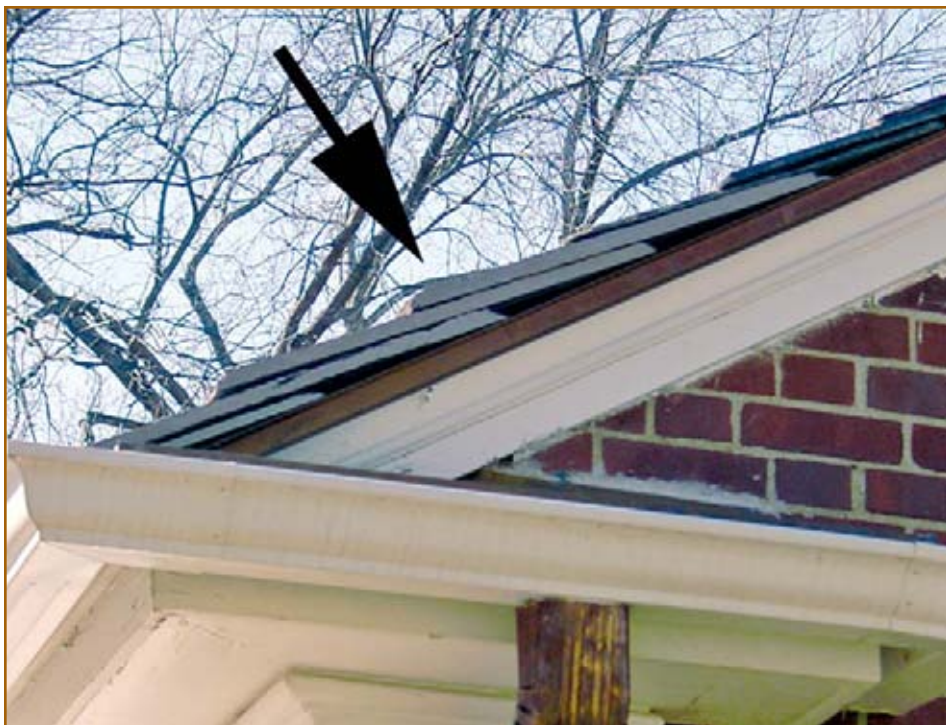
**Figure 32 – Diamond blades cut a square edge on slates, making them stick out like a sore thumb.**

Incorrect tools can be the downfall of many a would-be slater. Slate roofing has its own unique set of tools and equipment. For example, slates should be cut with – you guessed it – “slate cutters.” A slate cutter will leave a beveled edge on the shingle, thereby allowing it to match all the other shingles on the roof, all of which have beveled edges. If a diamond blade is used to cut the slates, a square edge remains, which can stick out like a sore thumb and get a roofer into big trouble if the property owner doesn't like the look of it. Figure 32 is

a perfect example of square edges exposed at the wrong place on a slate roof. These square edges could be dressed with a slate hammer and stake to give them the proper appearance, but one first must have these tools in the toolbox. When the proper cutter is not on hand, a roofer may resort to drastic measures to try to cut slates, as shown in *Figure 33*, where it looks like the slates were chewed off. This brand new roof, by the way, also had to be completely removed and reslated, causing the property owner much expense and grief.

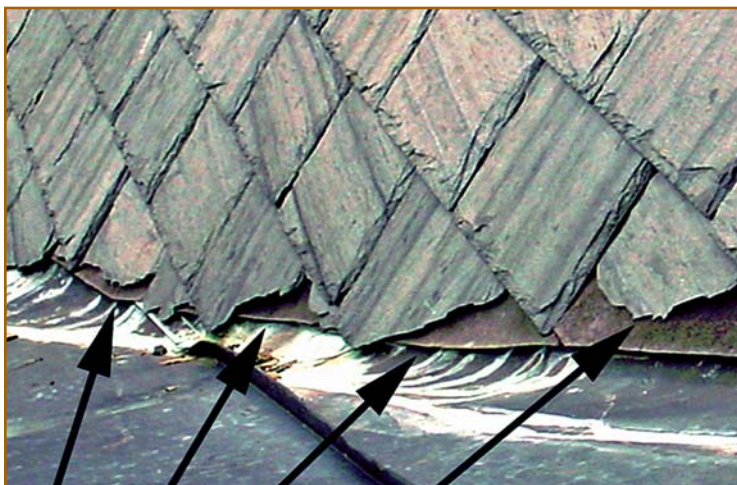
**Figure 33 – Slate roofing requires the correct tools to do the job right. There is no excuse for the sort of work shown here.**
